**Lampiran 1 (Material Properties Waste & Buttress In-Pit Dump
Seam 28-29)**

| Client : PT. JEMBAYAN MUARABARA (JMB) Project : Slope Stability Analysis of IPD 303 JMB Location : District of Separi - East Kalimantan Subject : Slope Stability Analysis | Date : September 26 th , 2019 Attention : Komang Suandra : : | |

1. PROBLEM

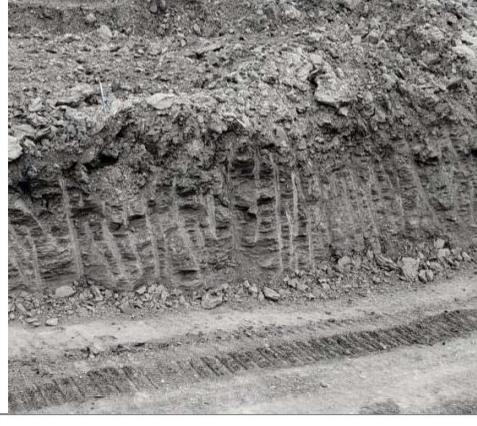
<p>Condition of Coal Seam 28L & Interbed Material</p> | | | | | | | | |

| Soil Type | c (kPa) | ϕ (°) | Coal Seam 28L | 223 | 55 | Interbed Material | 157 | 59 |
| Soil Type | c (kPa) | ϕ (°) | | | | | | | |
| Coal Seam 28L | 223 | 55 | | | | | | | |
| Interbed Material | 157 | 59 | | | | | | | |
| <p>Comment: Both coal seam 28L and interbed material should not be the trigger of encountered problem as predicted earlier. The laboratory results above showed good condition of coal seam 28L & interbed material as well as the existing condition as depicted below:</p> | | | | | | | | | |
|

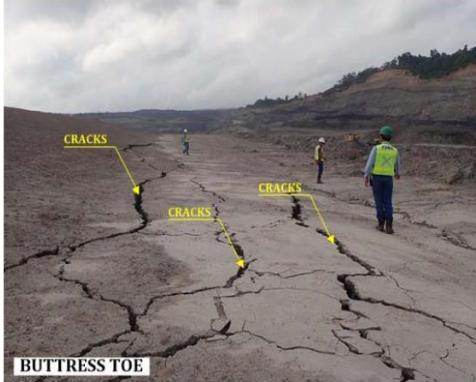
BUTTRESS TOE

- Crack line on RL +40 m
- Crack line on RL +0 m
- Crack line at toe of buttress
- Ground subsidence along the crack line on RL +40 m

CRACKS

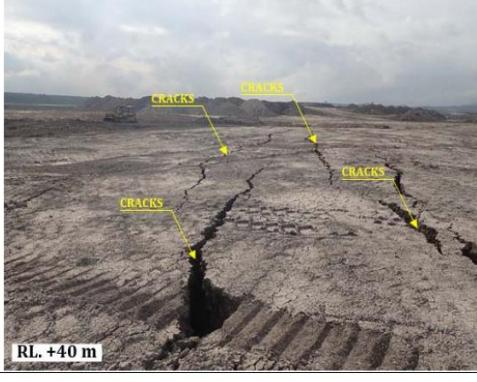
RL. +40 m

CRACKS

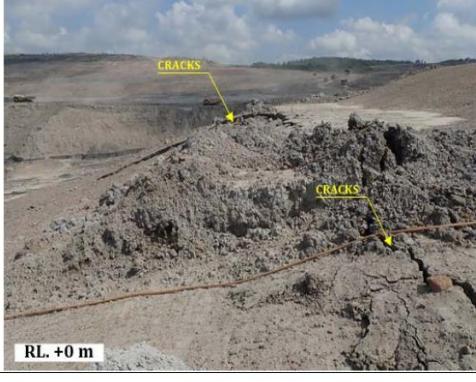
RL. +0 m

CRACKS

Preliminary suspect that generate problem on IPD 303 JMB is the bedding shear of coal seam 28L. Further action to prove this problem is by collecting core samples from 3 (three) boreholes (BR-01, BR-02 and BR-03) along the toe of buttress.
