**Lampiran 1 (Material Properties Waste & Buttress In-Pit Dump
Seam 28-29)**

| Client : PT. JEMBAYAN MUARABARA (JMB) Project : Slope Stability Analysis of IPD 303 JMB Location : District of Separi - East Kalimantan Subject : Slope Stability Analysis | Date : September 26 th , 2019 Attention : Komang Suandra : : | |

1. PROBLEM

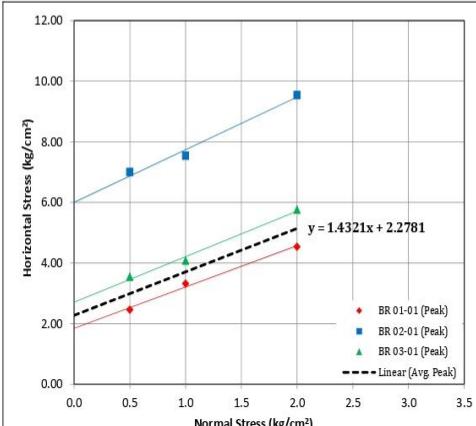
<p>Horizontal Stress (kg/cm^2)</p> <p>Normal Stress (kg/cm^2)</p> <p>$y = 1.4321x + 2.2781$</p> <p>BR 01-01 (Peak) (Red Diamond) BR 02-01 (Peak) (Blue Square) BR 03-01 (Peak) (Green Triangle) Linear (Avg Peak) (Black Dashed Line)</p> <p>Coal Seam 28L</p> |

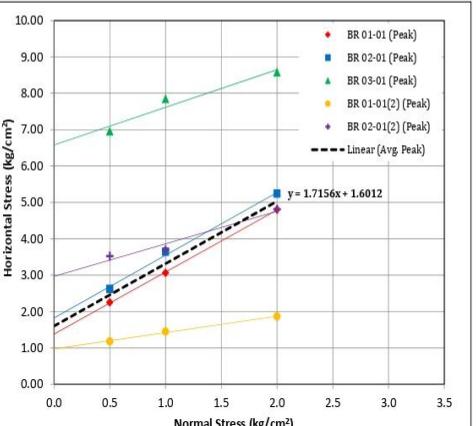
<p>Horizontal Stress (kg/cm^2)</p> <p>Normal Stress (kg/cm^2)</p> <p>BR 01-01 (Peak) (Red Diamond) BR 02-01 (Peak) (Blue Square) BR 03-01 (Peak) (Green Triangle) BR 01-01(2) (Peak) (Yellow Circle) BR 02-01(2) (Peak) (Purple Plus) Linear (Avg Peak) (Black Dashed Line) Linear (Avg Peak) (Blue Dashed Line)</p> <p>$y = 1.7156x + 1.6012$</p> <p>Interbed Material</p> | | | | | | | | |
| Summary strength properties of coal seam 28L and interbed material is presented as follow: | | | | | | | | | |
|

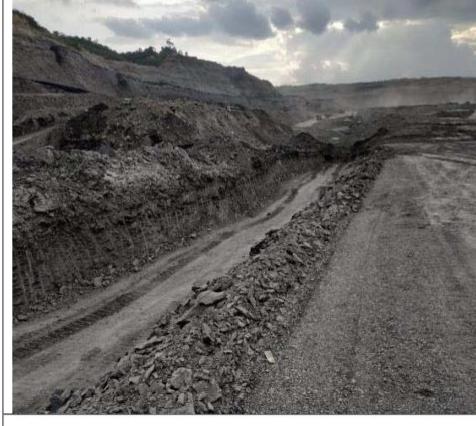
<p>Excavated Coal Seam 28L & Interbed Material</p> |

| Soil Type | c (kPa) | ϕ (°) | Coal Seam 28L | 223 | 55 | Interbed Material | 157 | 59 |
| Soil Type | c (kPa) | ϕ (°) | | | | | | | |
| Coal Seam 28L | 223 | 55 | | | | | | | |
| Interbed Material | 157 | 59 | | | | | | | |
| <p>Comment: Both coal seam 28L and interbed material should not be the trigger of encountered problem as predicted earlier. The laboratory results above showed good condition of coal seam 28L & interbed material as well as the existing condition as depicted below:</p> | | | | | | | | | |
|

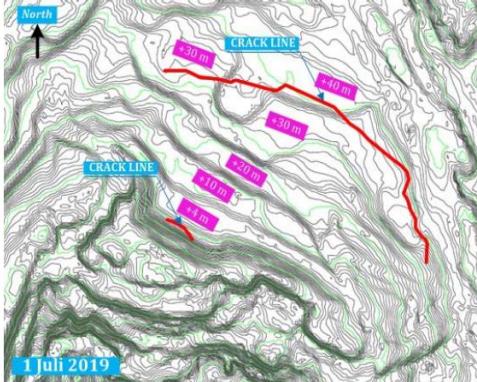
ZEKON has been invited by JMB to provide technical analysis to solve problem encountered at Input Dump 303 JMB. Our team visited the site on July 2019 to collect important information such as field documentations and other required data. General findings that encountered at IPD 303 JMB mentioned as follow:

- Crack line on RL +40 m
- Crack line on RL +0 m
- Crack line at toe of buttress
- Ground subsidence along the crack line on RL +40 m

Preliminary suspect that generate problem on IPD 303 JMB is the bedding shear of coal seam 28L. Further action to prove this problem is by collecting core samples from 3 (three) boreholes (BR-01, BR-02 and BR-03) along the toe of buttress.

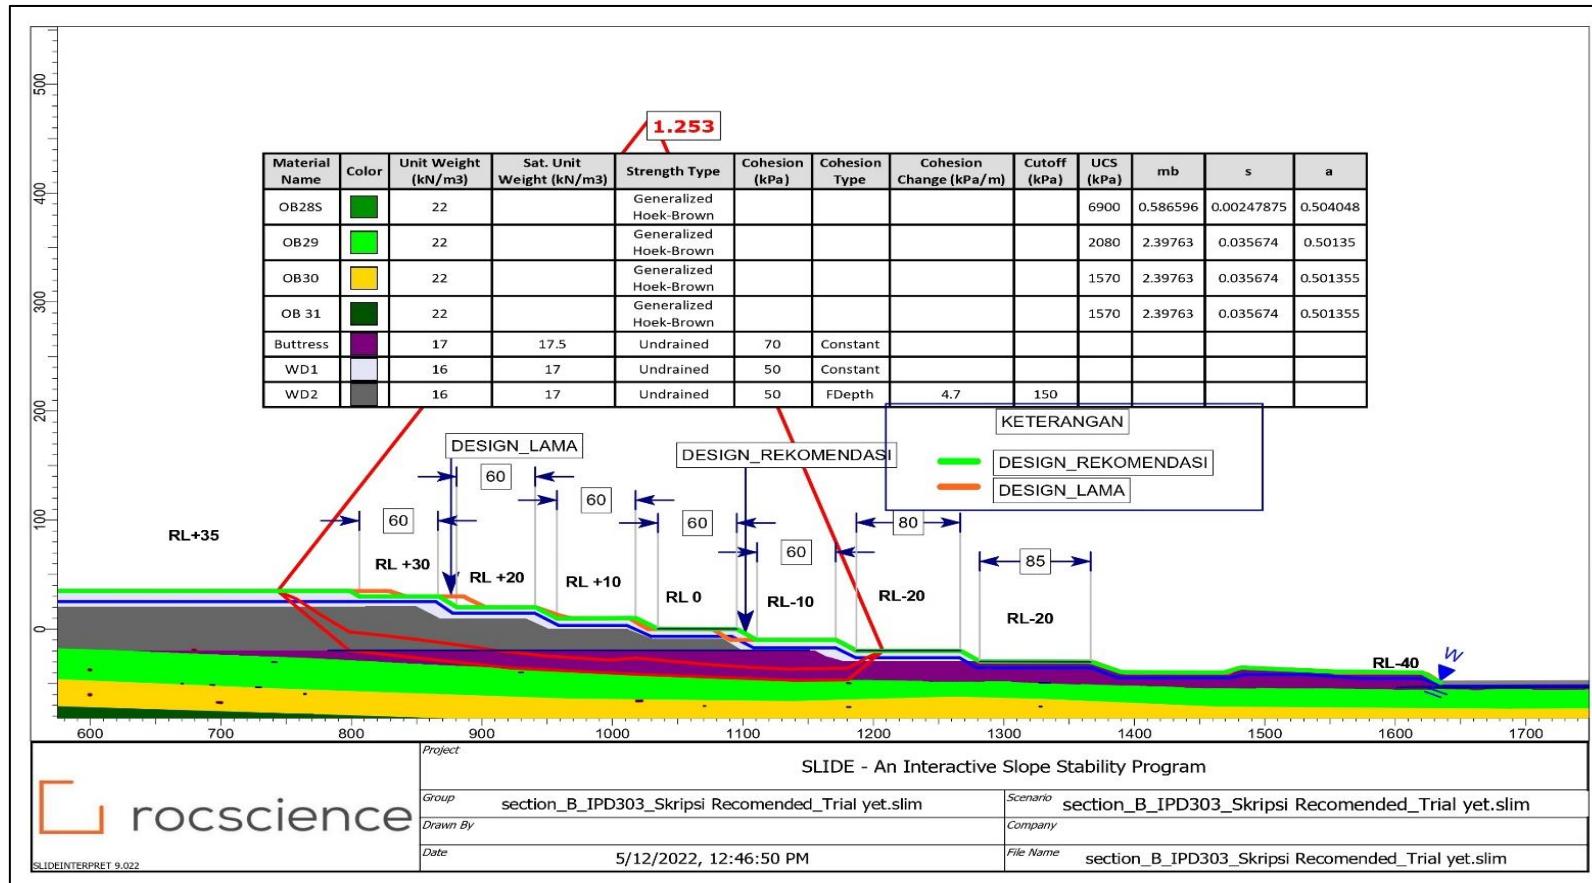
Lampiran 4 (Hasil Analisis Kestabilan Desain Lereng Rekomendasi *In-Pit Dump* Crossection B & C)
