A REVIEW ON IMAGE PROCESSING TECHNIQUES FOR DAMAGE DETECTION ON PHOTOVOLTAIC PANELS

ANDI NAJIAH NURUL AFIFAH¹, INDRABAYU², ANSAR SUYUTI¹ AND SYAFARUDDIN^{1,*}

Universitas Hasanuddin

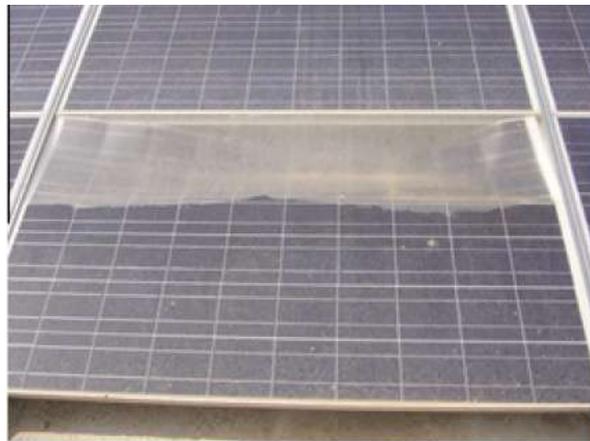
FIGURE 2. A PV module with delamination [10]

Delamination highly potentially occurs in hot and humid temperatures. If the problem appears in the edge of panels, it will be more severe not only because of the power losses but it is dangerous due to potential electrical risks of panels and the area of installation. Figure 2 shows an image of the worse delamination that could damage the PV panel when the defect appeared. Delamination is also correlated with light transmittance loss entering the panel surface as materials do not respond optically coupled with the loss part of sunlight [10].
